# More than just a terrace: A PAST PERSPECTIVE ON THE MULTIFUNCTIONAL AGRICULTURE OF KONSO, ETHIOPIA

RESEARCH ASSOCIATE, THE ARCHAEOLOGY OF  
AGRICULTURAL RESILIENCE IN EAST AFRICA,  
UNIVERSITY OF YORK, UK

PRINCIPLE INVESTIGATOR, THE ARCHAEOLOGY OF  
AGRICULTURAL RESILIENCE IN EAST AFRICA AND  
TERRACES: RESISTANCE AND RESILIENCE OF  
AGRICULTURAL SOILS, UNIVERSITY OF YORK, UK

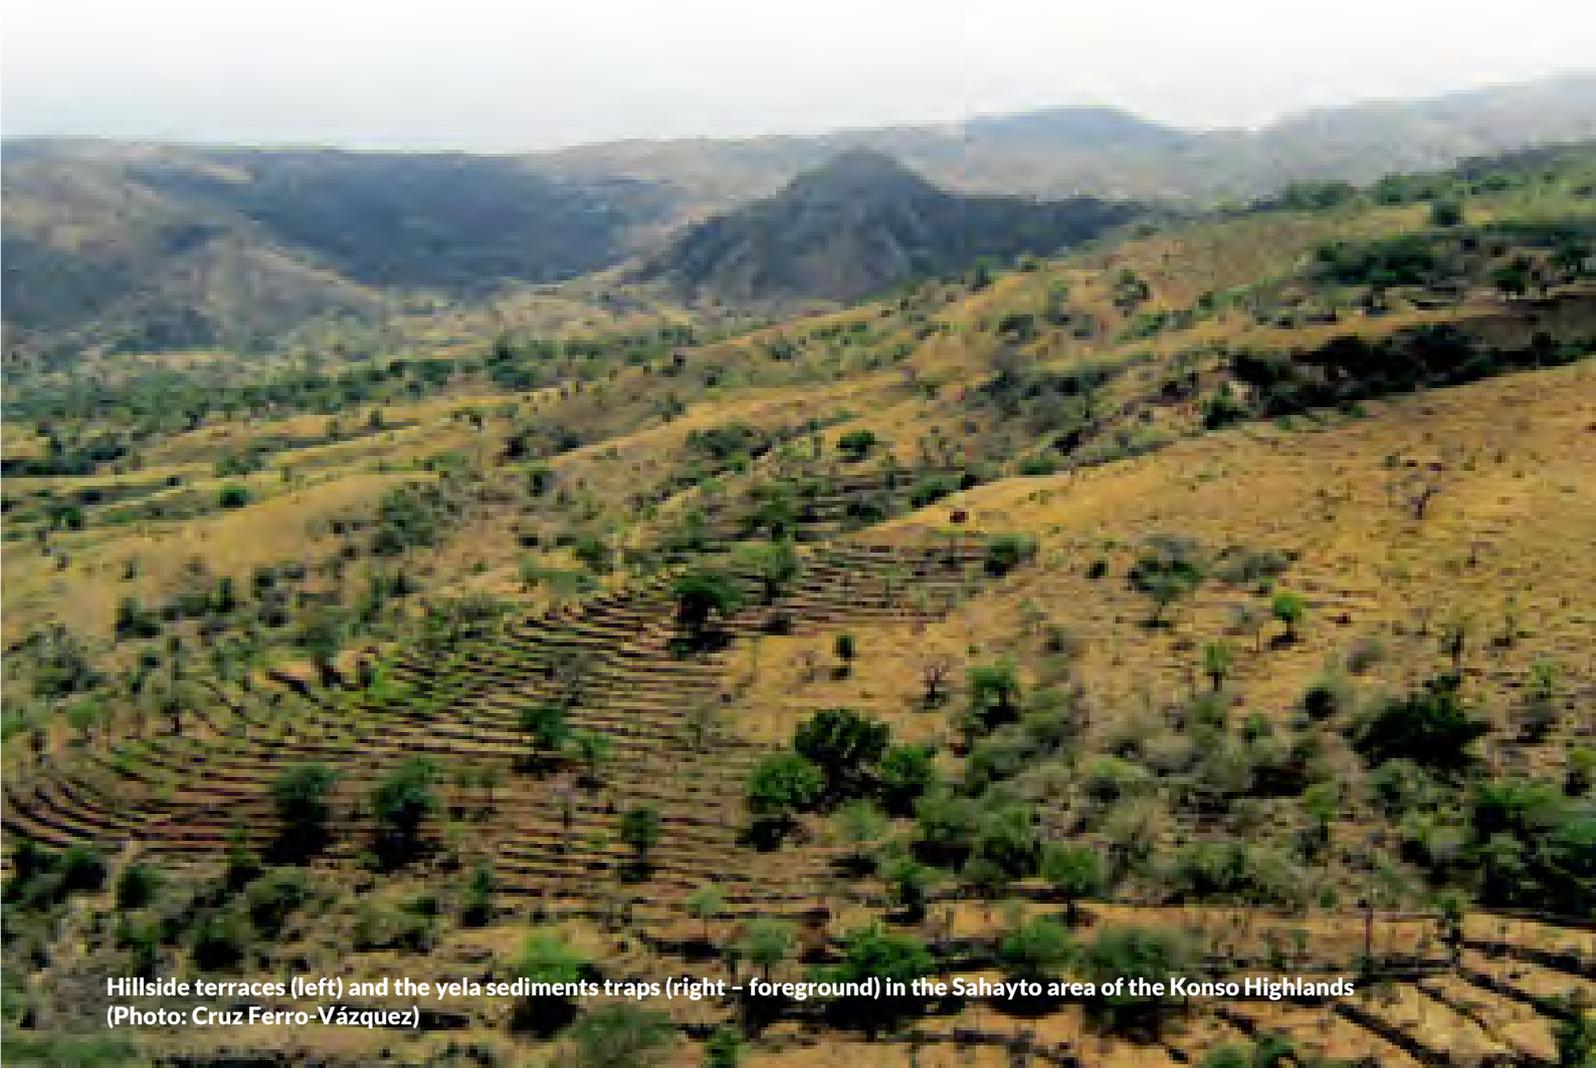
**Hillside terraces (left) and the yela sediments traps (right - foreground) in the Sahayto area of the Konso Highlands (Photo: Cruz Ferro-Vázquez)**

The archaeological data from Konso has revealed a strikingly different story of development. The terraces were not originally built to increase the amount of cultivatable land, but were a complex system of sediment traps. The main agricultural land was in the valley bottoms, in areas called yela, where alluvial soils were captured. Whilst soils were certainly eroding from the surrounding slopes, the initial construction of the terraces was to keep this material back from the more valuable yelas below. The yelas are still regarded as important today, but the link between the terraces and yela, and understanding the initial reason for terrace construction had been lost until this current work was undertaken.

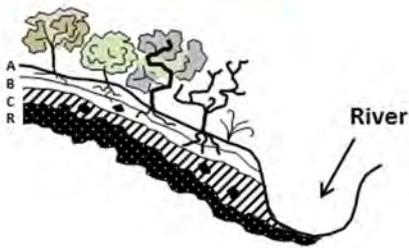
(1) Pre-disturbance hillside

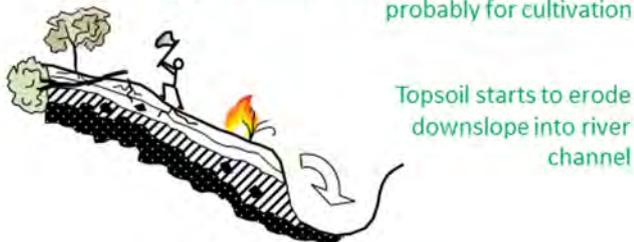
(2) Vegetation clearance by slash and burn, probably for cultivation

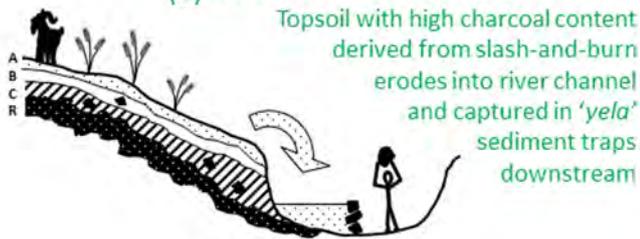
(3) Deforestation of hillside causes erosion. Topsoil with high charcoal content erodes into river channel and captured in 'yela' sediment traps downstream

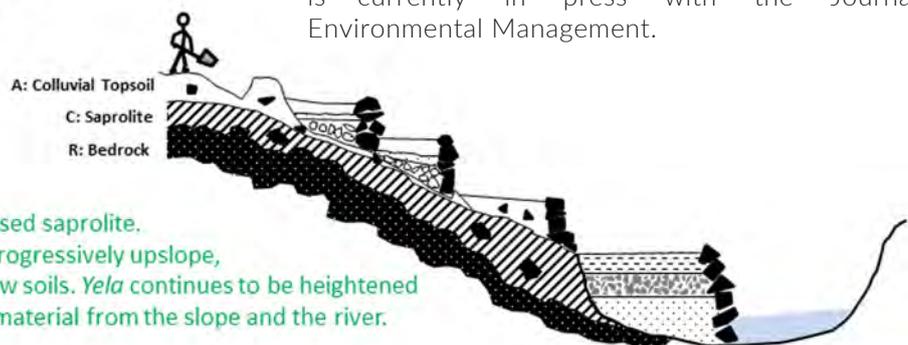
(5) Need to protect yela fields from stoney colluvium leads to construction of terraces at base of slope, some founded directly on exposed saprolite. Further hillside terraces built progressively upslope, eventually helping to create new soils. Yela continues to be heightened by controlled accumulation of material from the slope and the river.
